## **High-quality epoxy powder coating on valves and fittings makes water networks durable: Results from the 25-year Bad Bentheim long-term trial**

### **Background and objectives of the test**

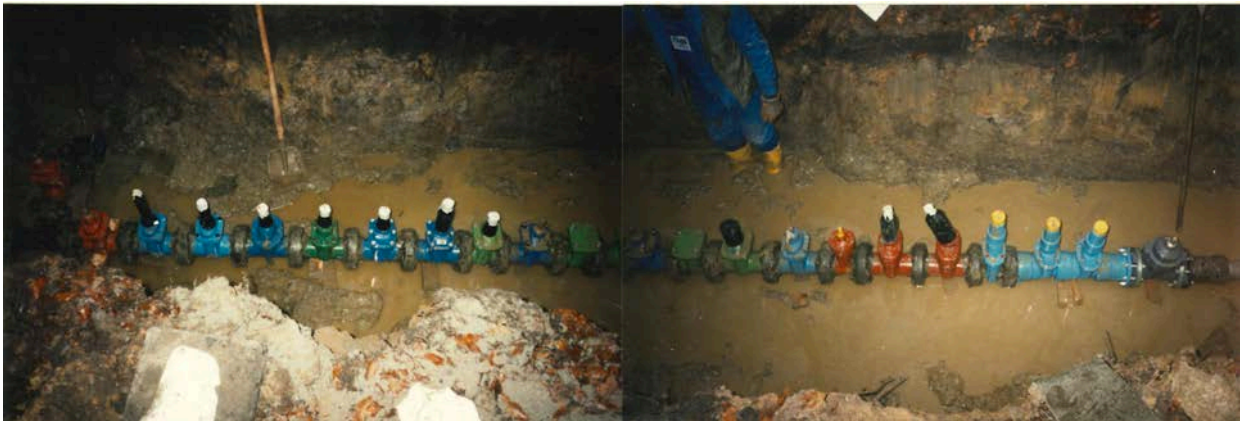
Test section consisting of 26 valves and fittings during installation in 1996

On 13 December 1996, a total of 18 gate valves and 8 fittings were installed in a drinking water pipe belonging to the Wasserverband Bad Bentheim. Most of these components were coated with an epoxy powder coating, while some samples were treated with an enamel coating on the inside surface or a liquid coating. In order to test the load capacity of the coatings under extreme conditions, an artificial defect with a diameter of 6 mm was applied to all samples. This simulates

possible damage to the coating that could occur during installation and enabled a realistic assessment of the corrosion protection.

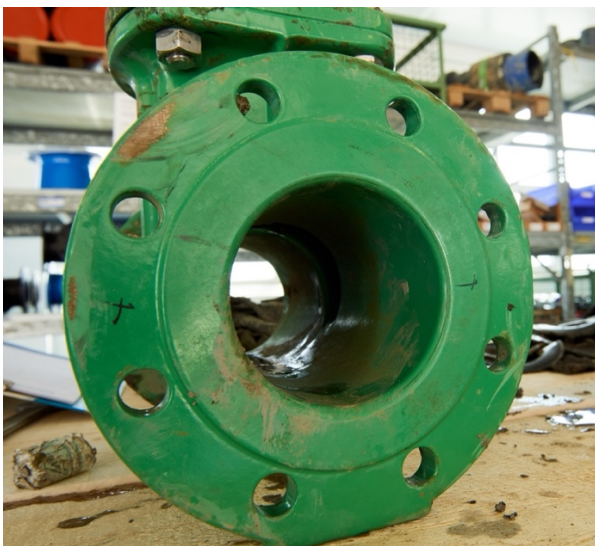
Close-up of a gate valve immediately after removal:  
no corrosion visible on the inside surface.

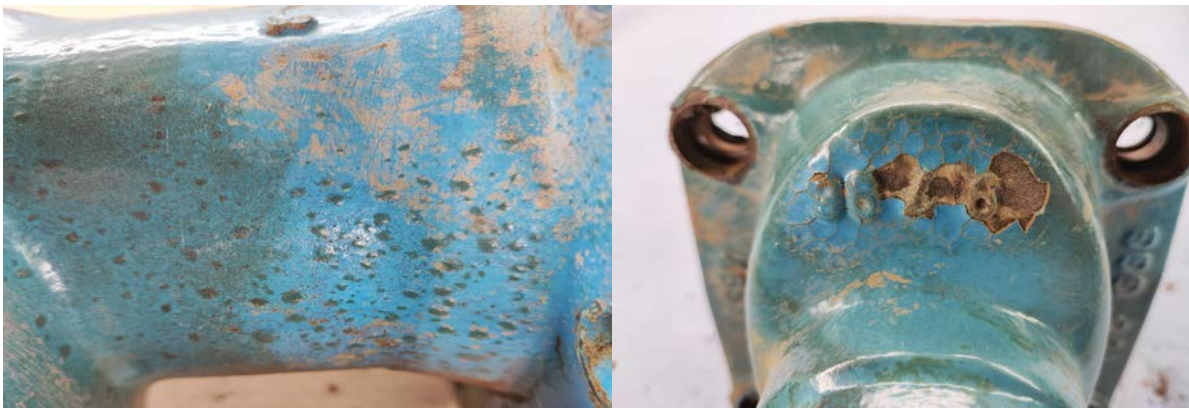
Blistering on the gate valve body; cracking and corrosion on the outer coating of the cap

Another sample, on the other hand, showed pronounced blistering on the outside surface as well as cracks in the coating and corrosion on the top of the cap. This damage, which occurred in contrast to the other 19 powder-coated samples, can be attributed to faulty process control during coating. Possible reasons for this could be inadequate surface preparation or too low a temperature control, which can lead to incomplete cross-linking of the coating.

In contrast to most of the other gate valves analyzed, this sample was not subject to GSK quality assurance. The defects that occurred therefore emphasize the crucial importance of quality assurance in the coating process. Such failures, which can be attributed to inadequate process control, confirm GSK's 35-year commitment to seeing quality assurance as an integral part of the entire coating process - from workpiece preparation to temperature control and application through to final inspection - and to having this monitored by independent testing institutes.

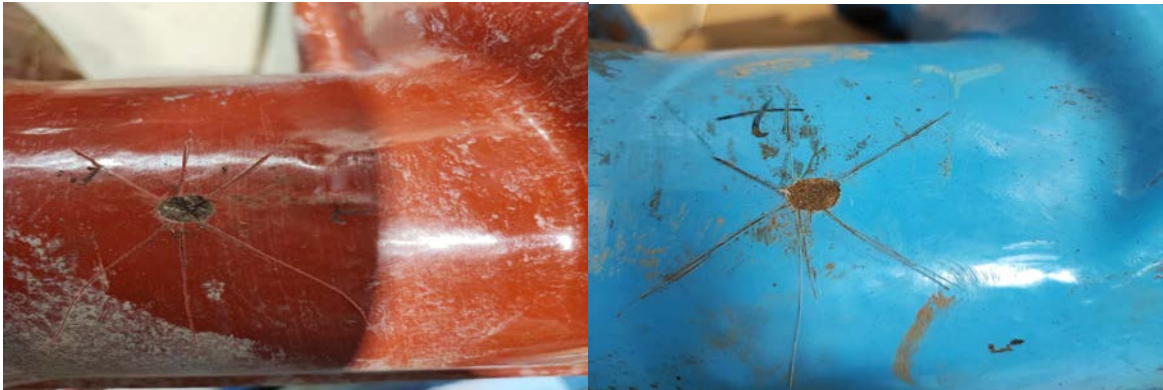
Close-up of the artificial defect: no corrosion or delamination visible

The artificially created defects, which were supposed to be particularly susceptible to infiltration, showed only minimal impairment, with maximum infiltration values of just 2 mm.
